## \* Test Data(Graph)

### 1. Up Link

| | Customer | KJ Code | FT00311-6/1 |

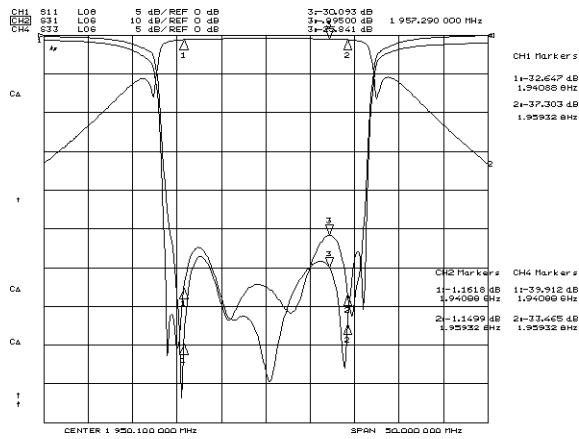
#### # Insertion Loss # Return Loss

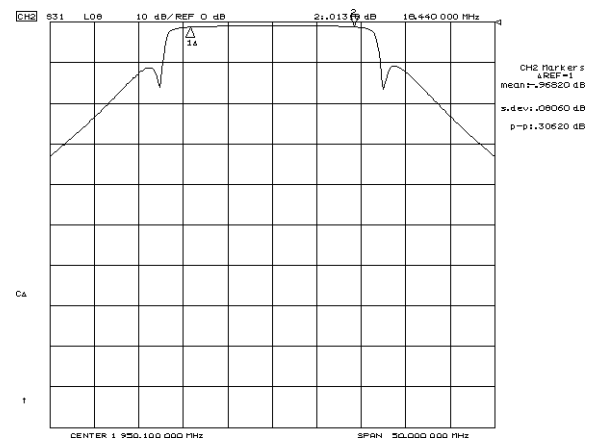
#### # Pass Band Ripple

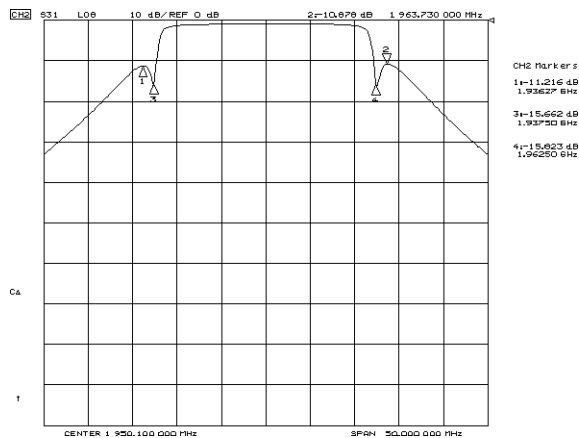
#### # Attenuation[1937.5MHz/1962.5MHz]

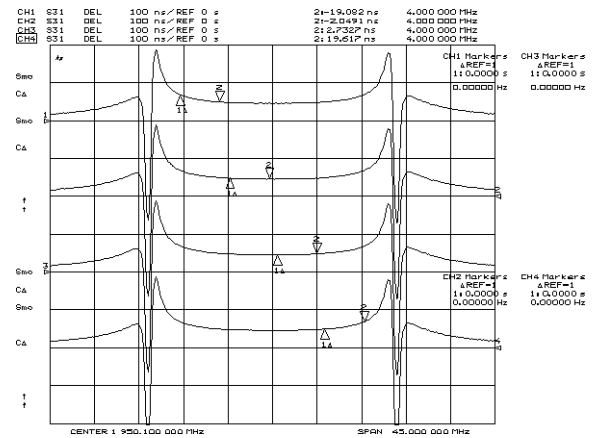
#### # Group Delay

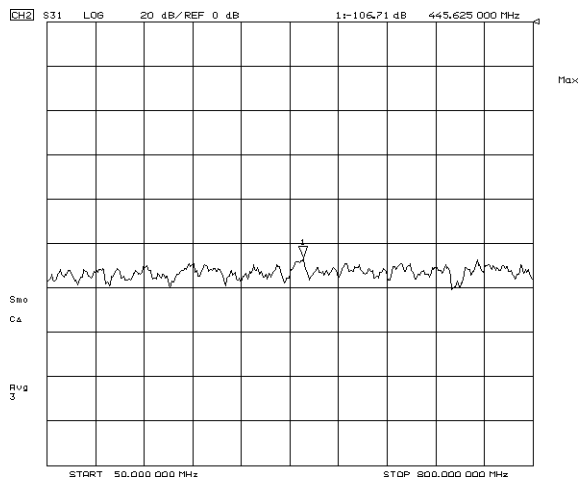
### # Attenuation[9KHz~800MHz]

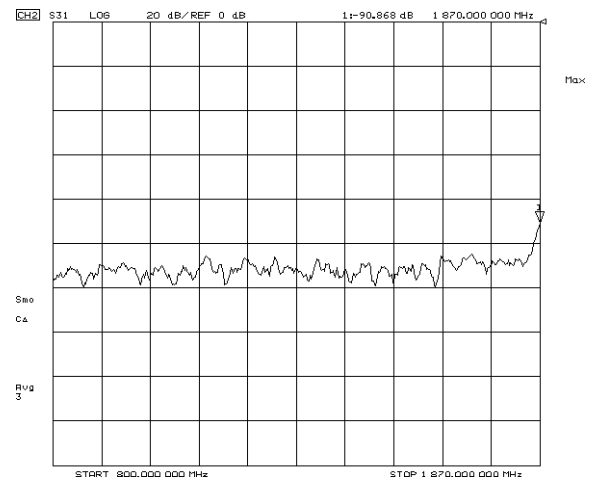
### # Attenuation[800MHz~1870MHz]

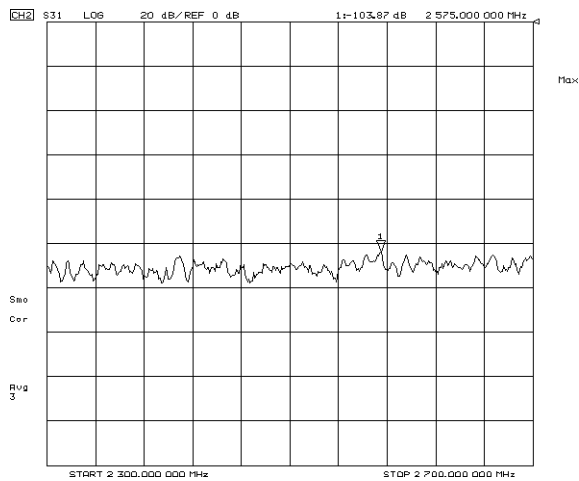
### # Attenuation[2.3GHz~2.7GHz]

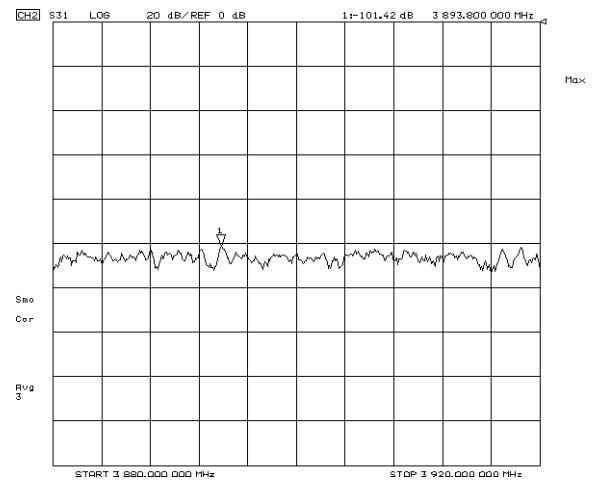
### # Harmonic[2<sup>nd</sup>]

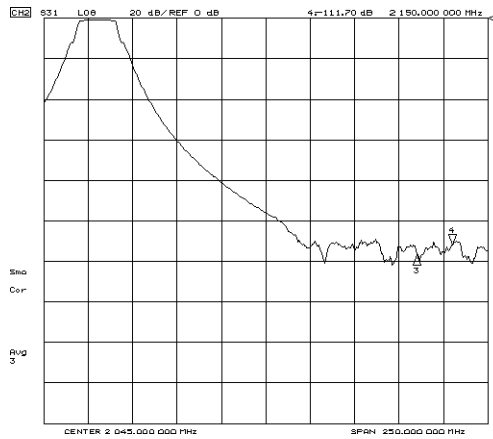
### # Isolation

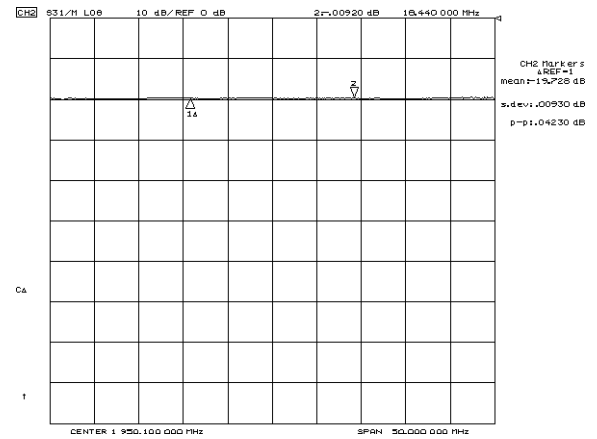
### # Output Coupling Value

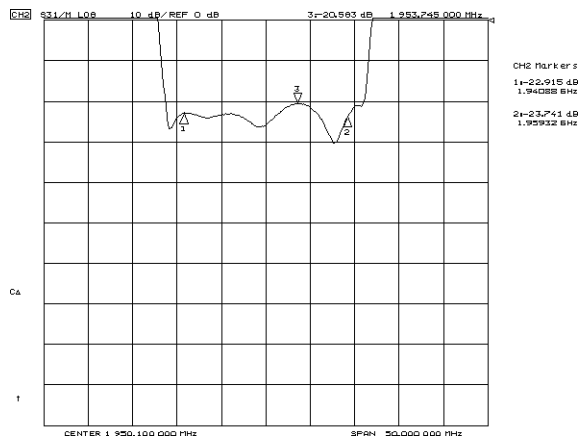
### # Directivity

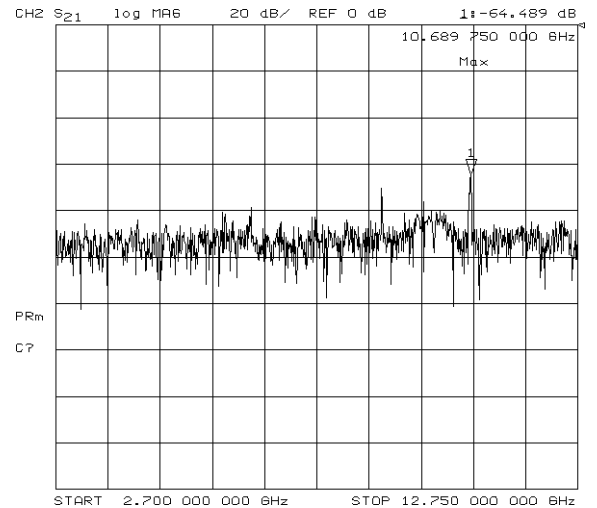
### # Attenuation[2.7~12.75GHz]

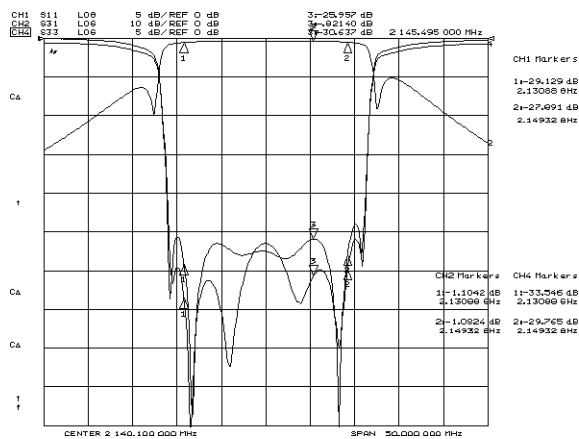
### # Insertion Loss # Return Loss

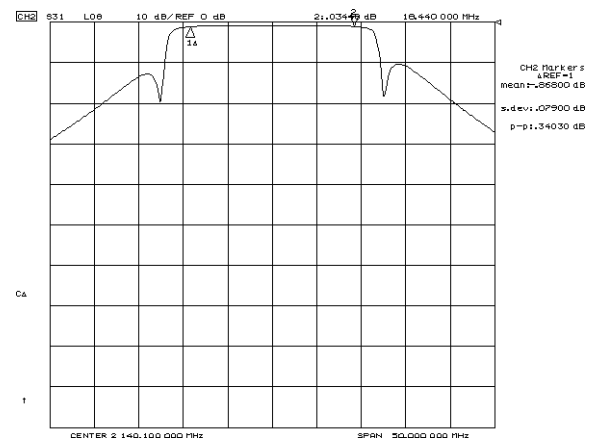
### # Pass Band Ripple

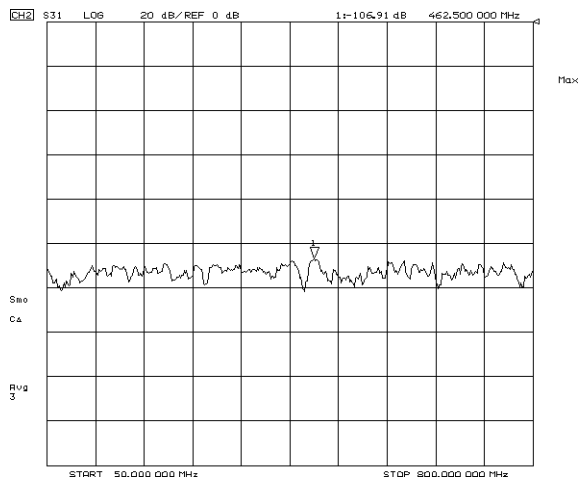
### # Attenuation[9KHz~800MHz]

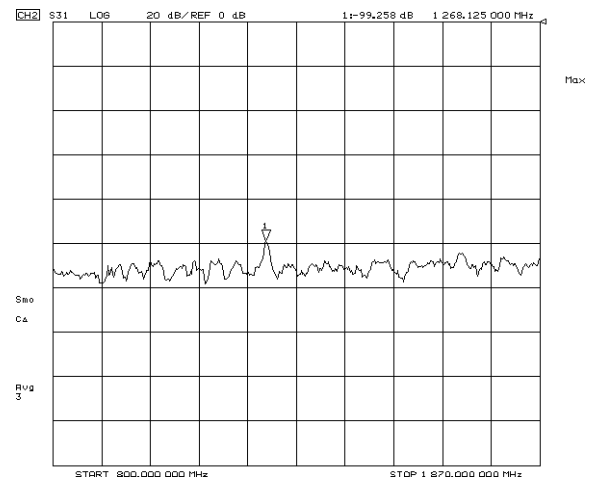
### # Attenuation[800~1870MHz]

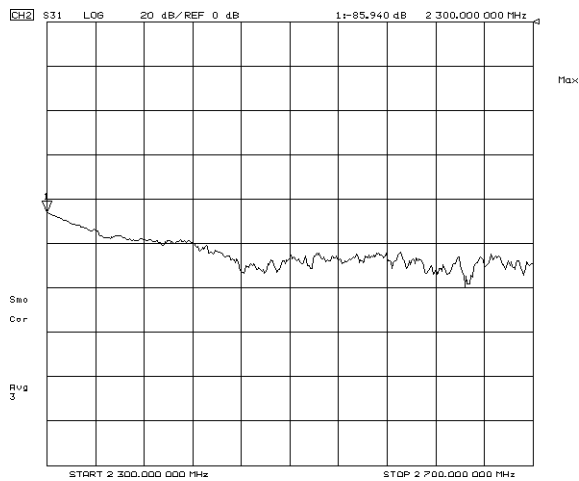
### # Attenuation[2.3~2.7GHz]

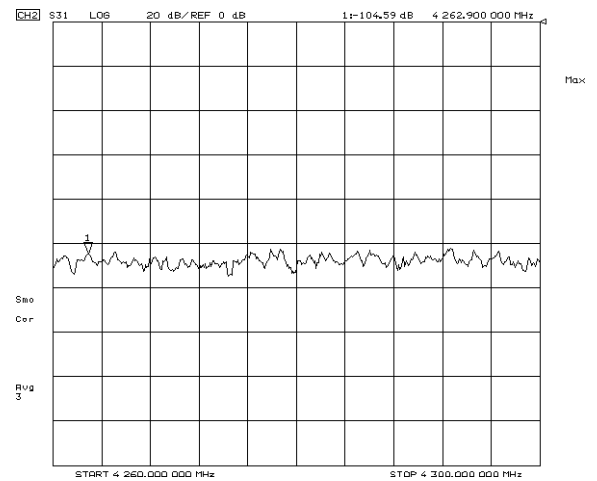
### # Harmonic[2<sup>nd</sup>]

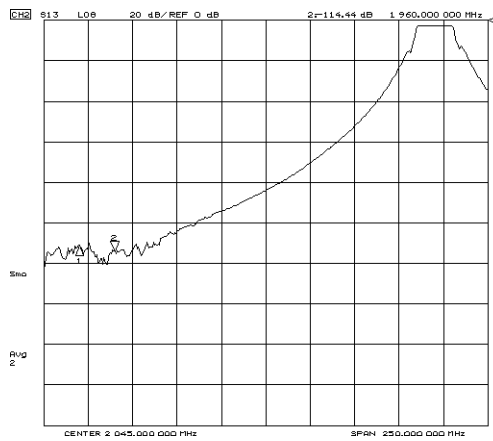
### # Isolation

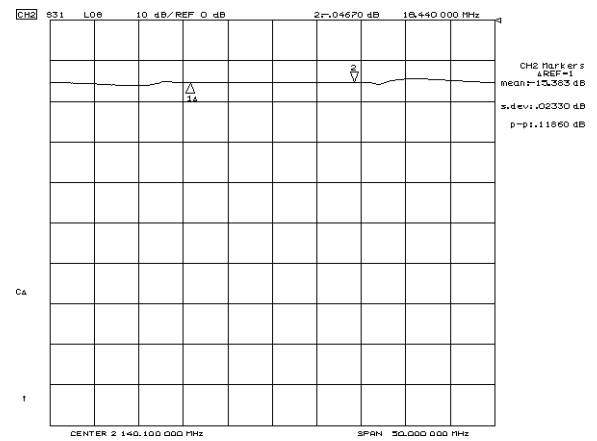
### # Input Coupling Value
