## \* Test Data (Graph)

| | Customer | KJ Code | FT00319-6/1 |

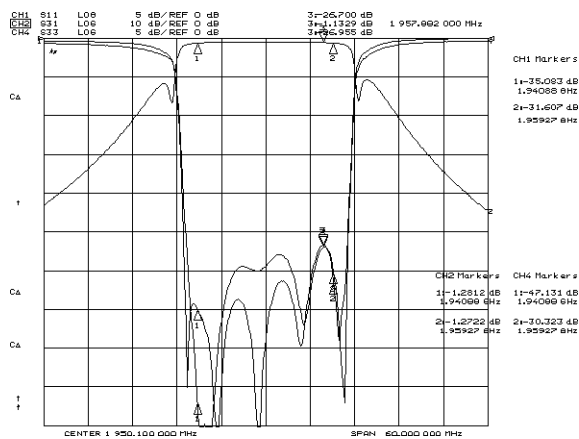
#### # Insertion Loss # Return Loss

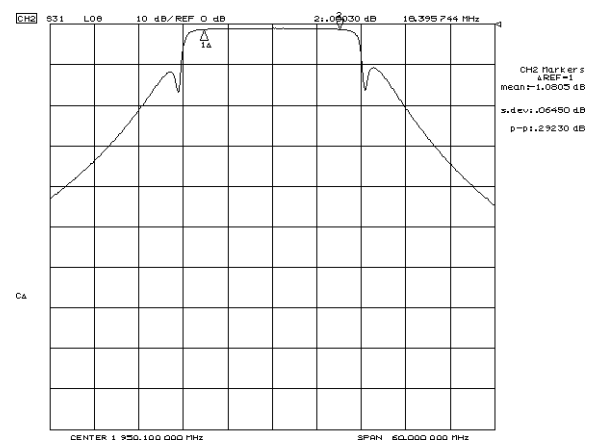
#### #Pass Band Ripple

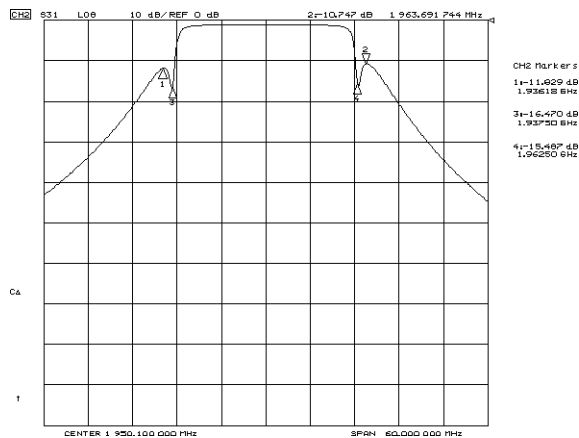
#### #Attenuation[1937.5/1962.5MHz]

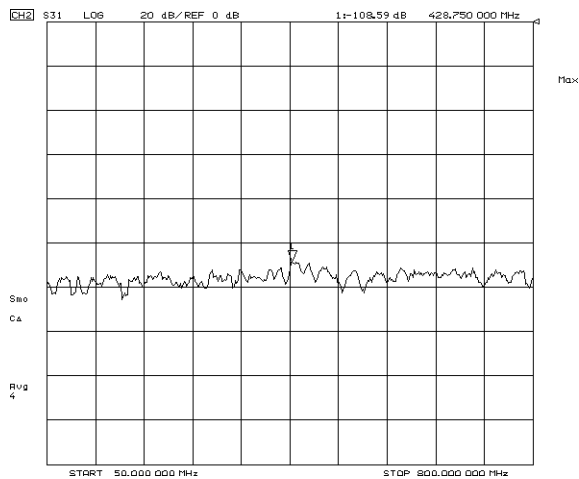
### #Attenuation[9KHz~800MHz]

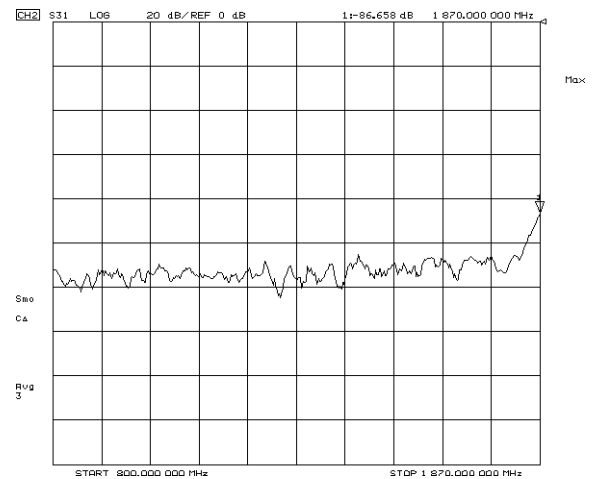
### #Attenuation[800~1870MHz]

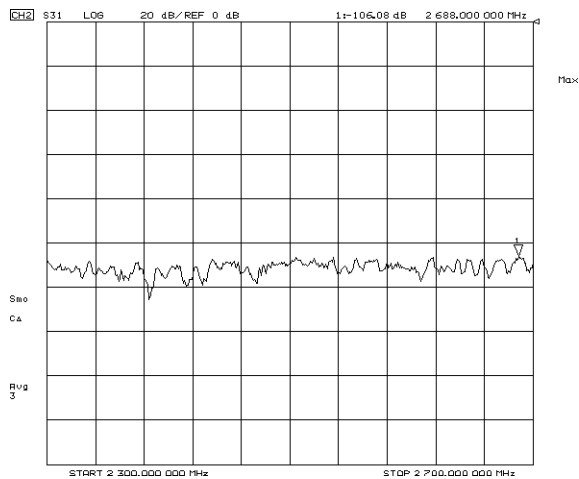
### #Attenuation[2300~2700MHz]

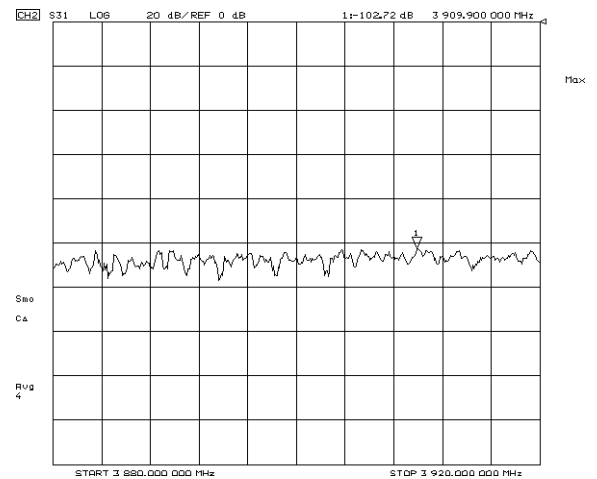
### #2<sup>nd</sup> Harmonic

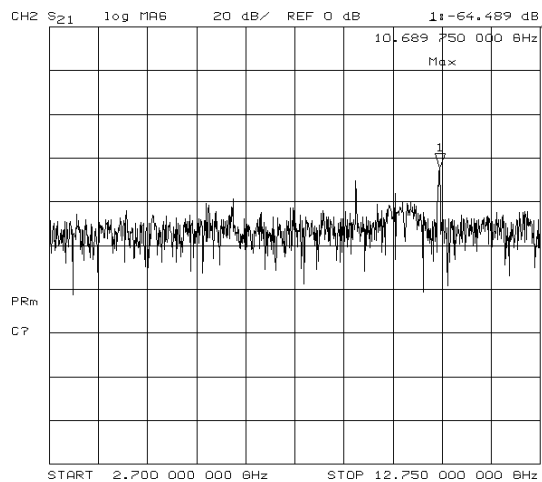
### #Attenuation[2700MHz~12.75GHz]

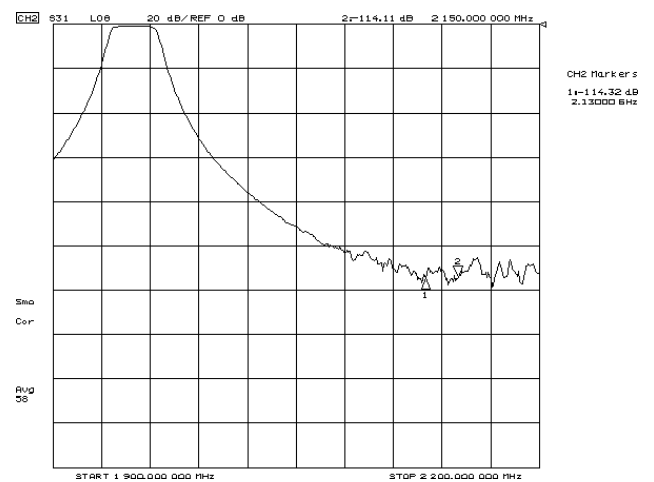
### #Isolation

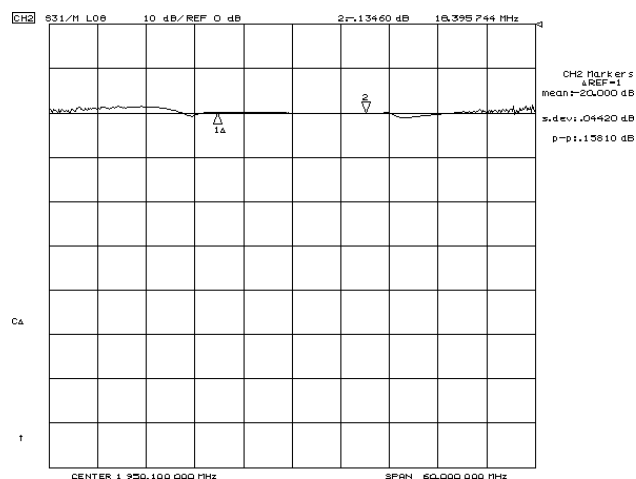
### #Coupling Value[ANT Port Out]

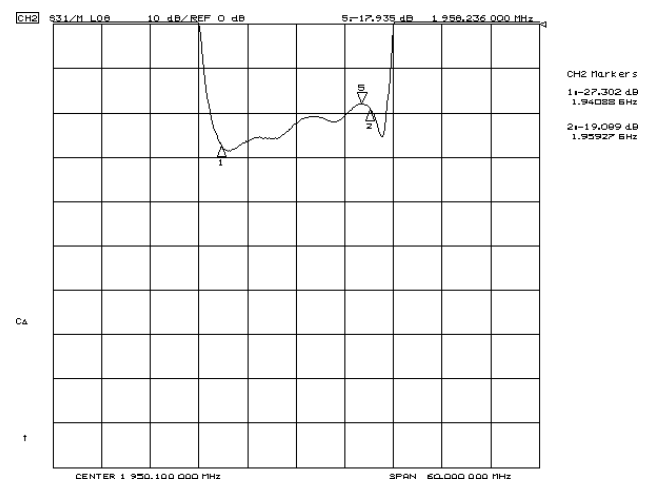
### #Coupling Port Directivity

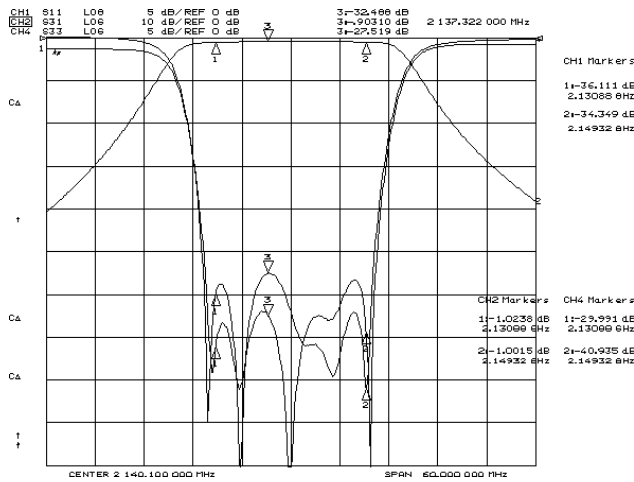
### #Insertion Loss #Return Loss

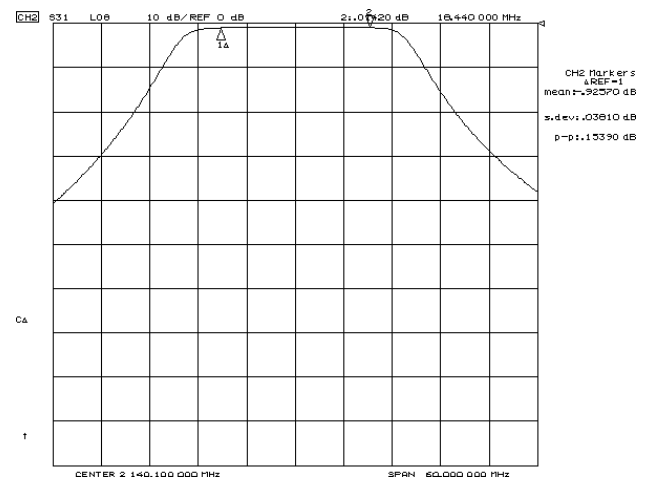
### #Pass Band Ripple

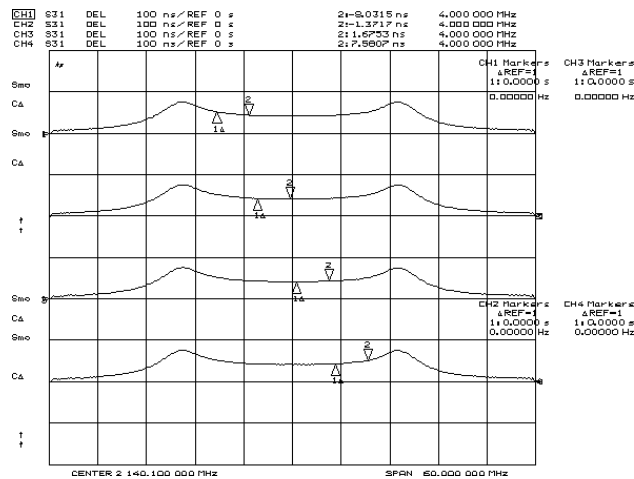
### # Group Delay

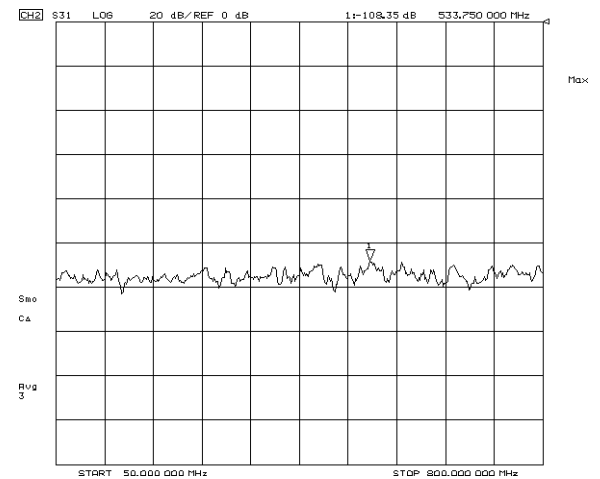
### # Attenuation[9KHz~800MHz]

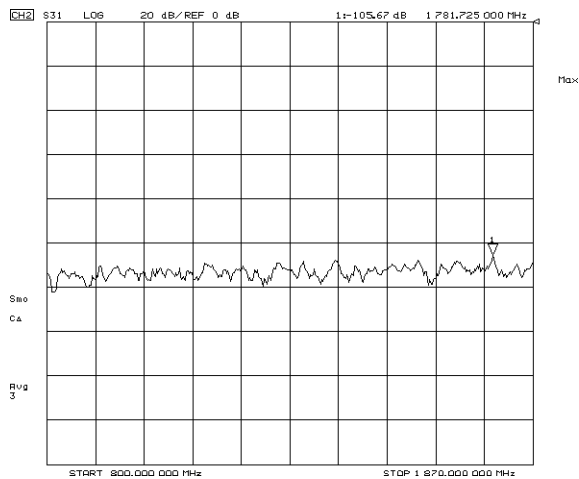
### # Attenuation[800~1870MHz]

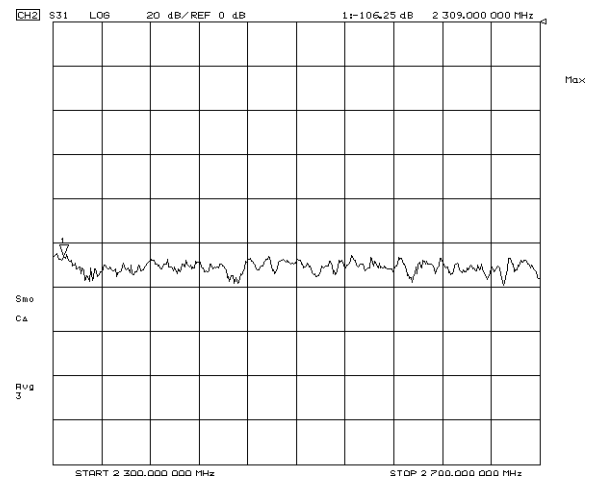
### # Attenuation[2300~2700MHz]

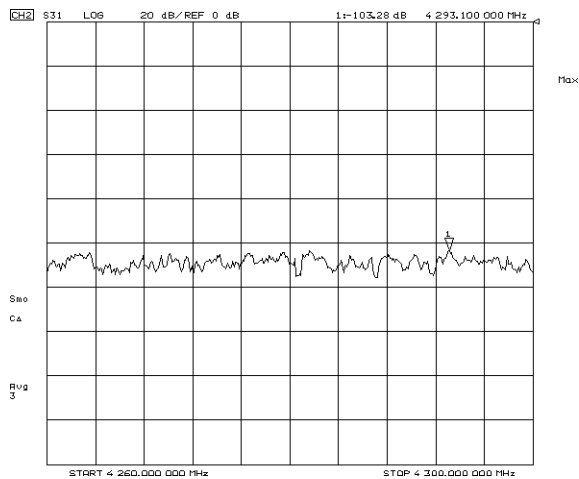
### # 2<sup>nd</sup> Harmonic

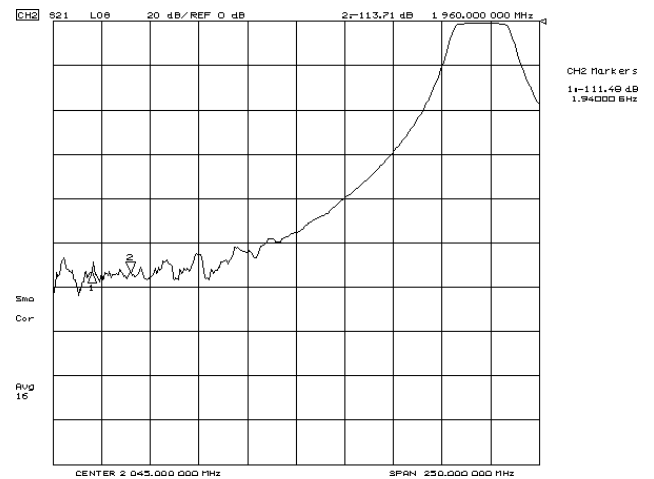
### # Isolation

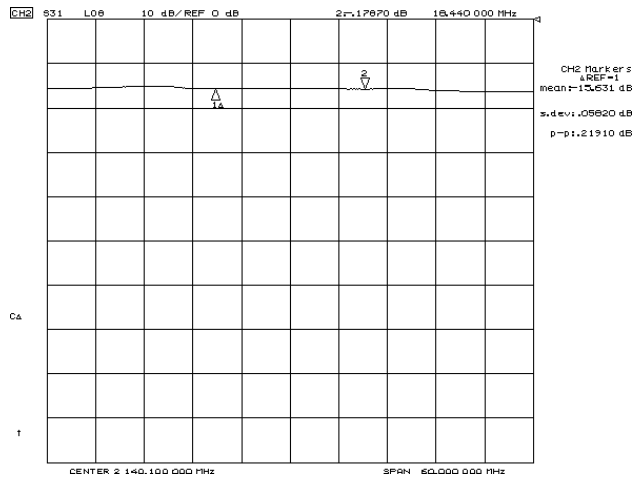
### # Coupling Value[ANT Port Out]

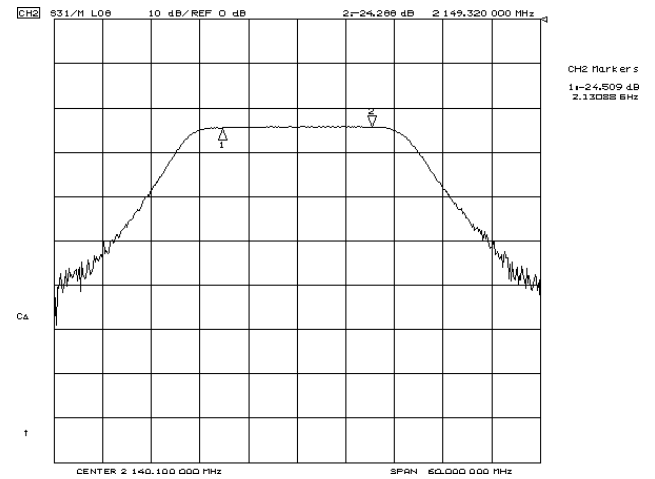
### # Coupling Port Directivity
