<b>KJ</b> <b>COMTECH</b>	Date	Version No.	1.0
	Customer	KJ Code	FT00312-6/1

## \* Test Data(Graph)

### 1. Up Link

## 2. Down Link

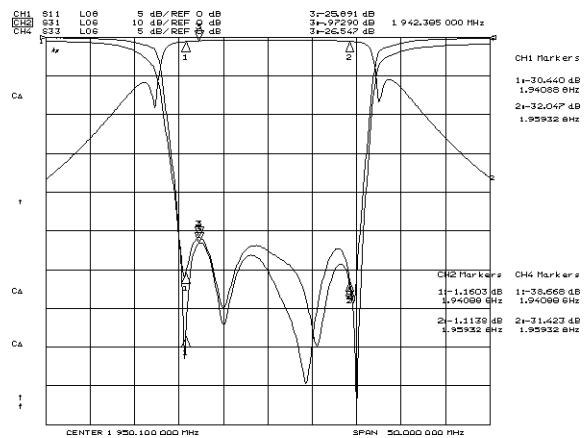
# Insertion Loss

#Return Loss

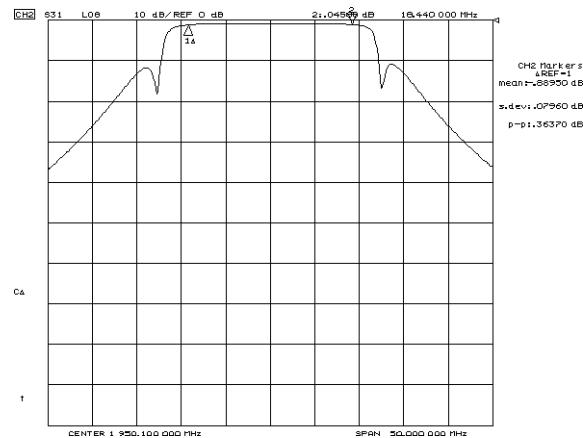
# Pass Band Ripple

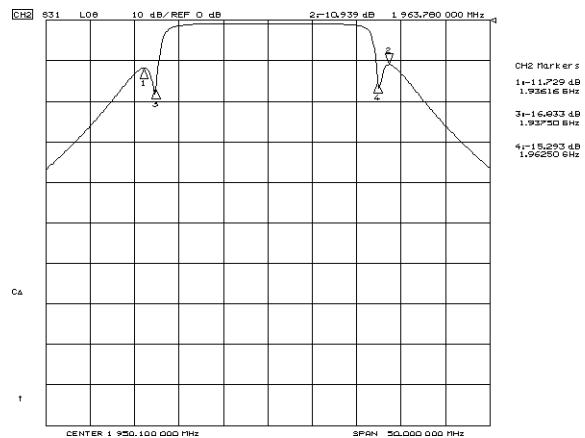
# Attenuation[1937.5MHz/1962.5MHz]

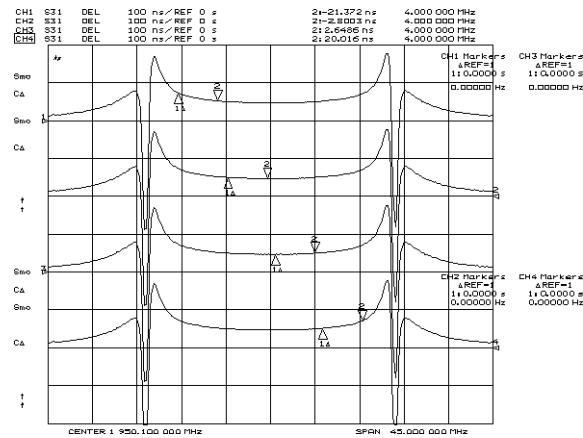
# Group Delay

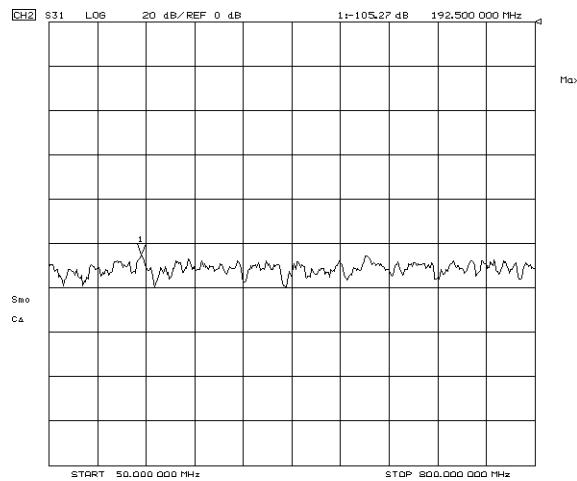
# Attenuation[9KHz~800MHz]

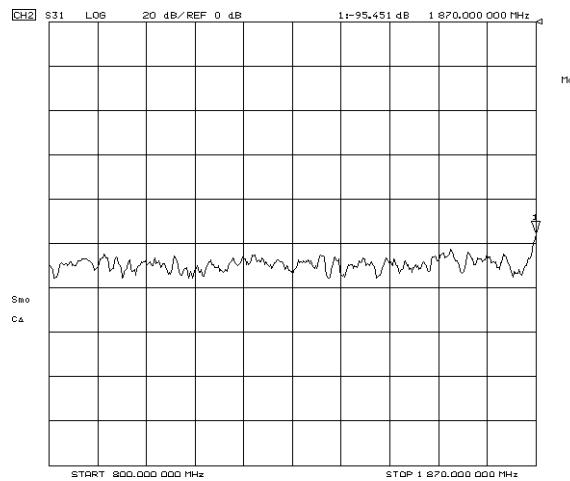
# Attenuation[800~1870MHz]

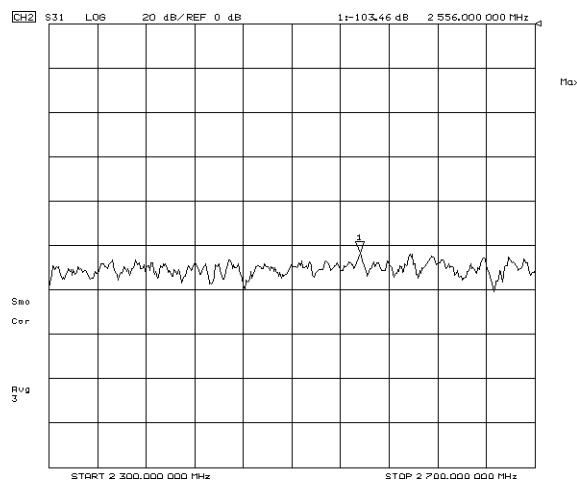
# Attenuation[2.3~2.7GHz]

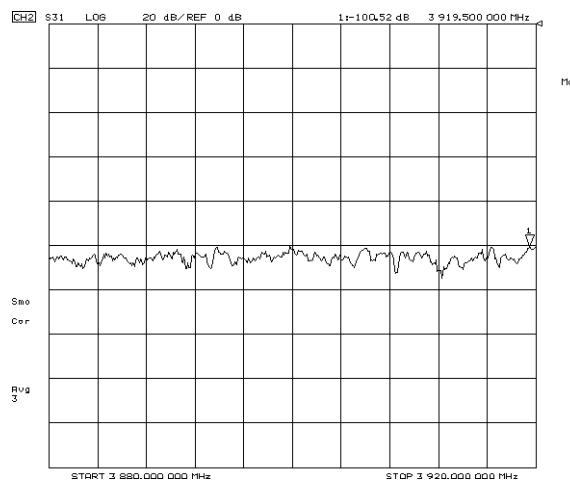
# Harmonic[2<sup>nd</sup>]

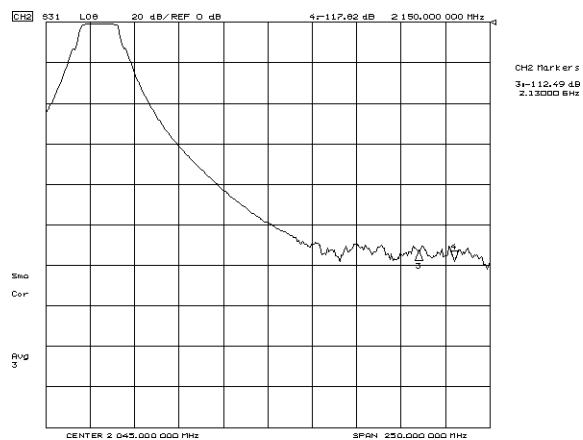
### # Isolation

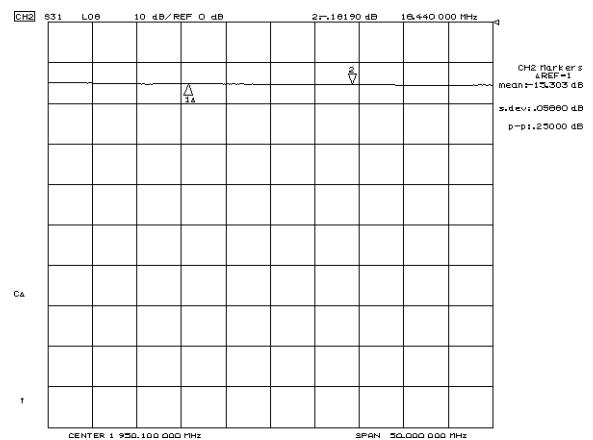
### # Input Coupling Value

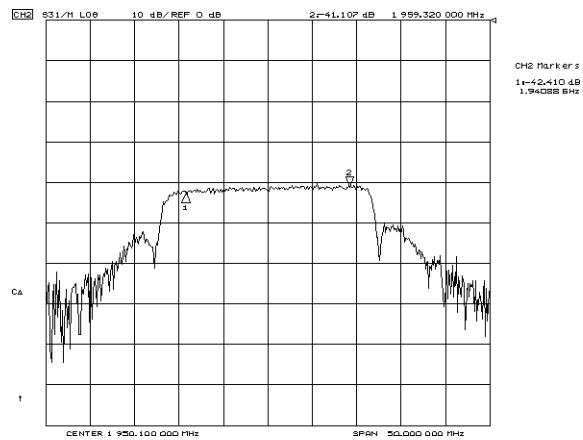
### # Directivity

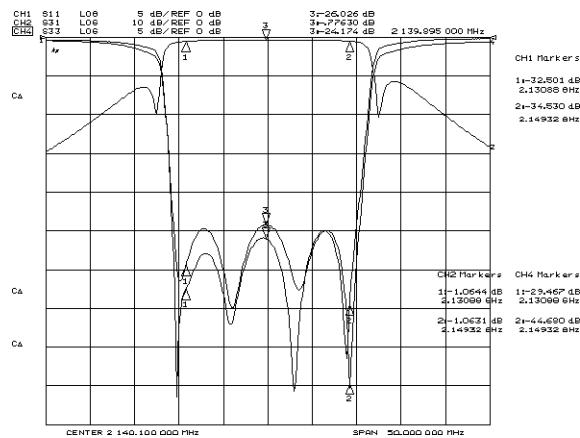
# Insertion Loss    # Return Loss

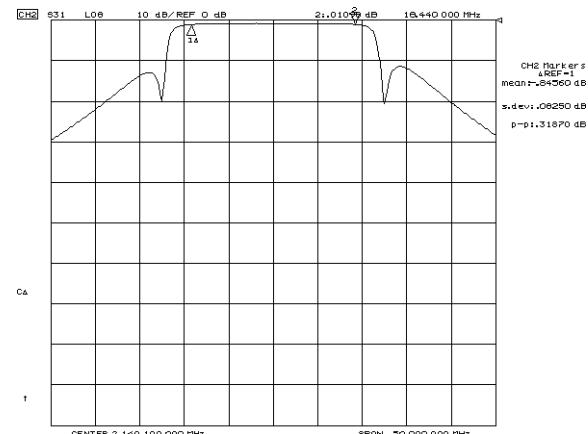
# Pass Band Ripple

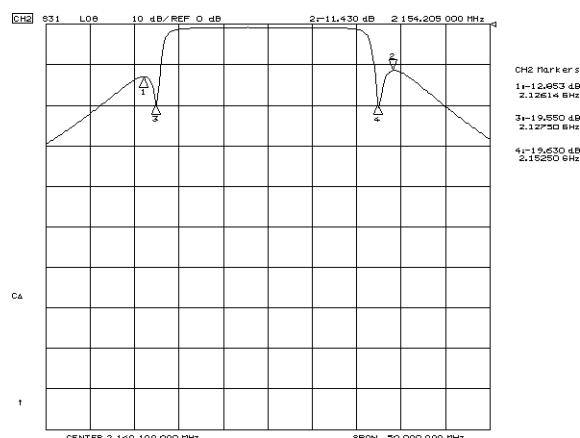
# Attenuation[2127.5MHz/2152.5MHz]

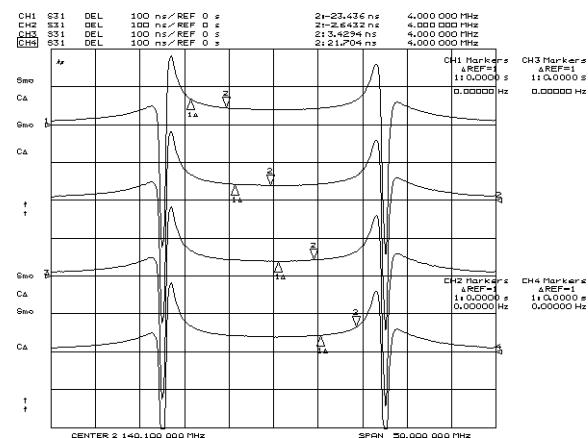
# Group Delay

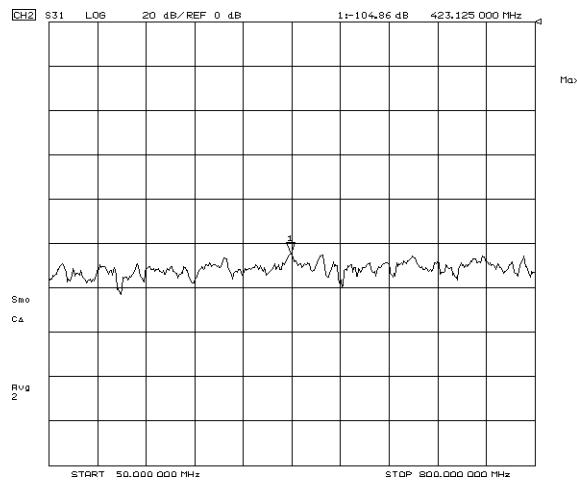
# Attenuation[9KHz~800MHz]

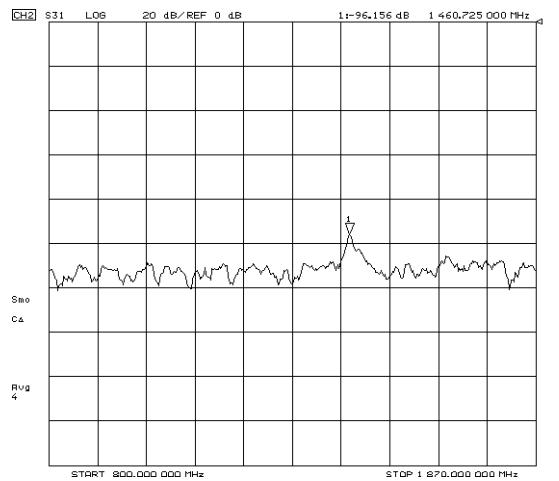
# Attenuation[800~1870MHz]

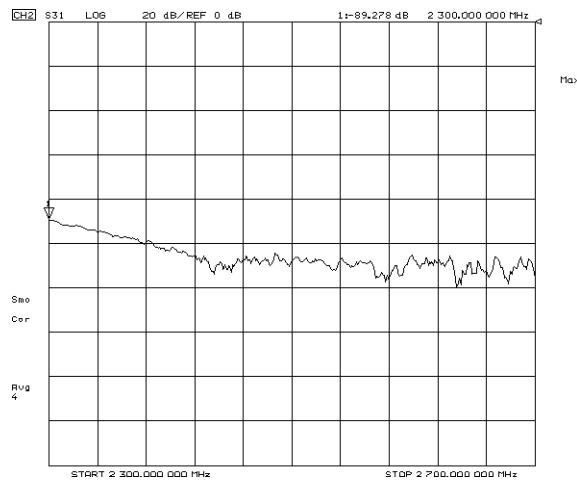
# Attenuation[2.3~2.7GHz] #

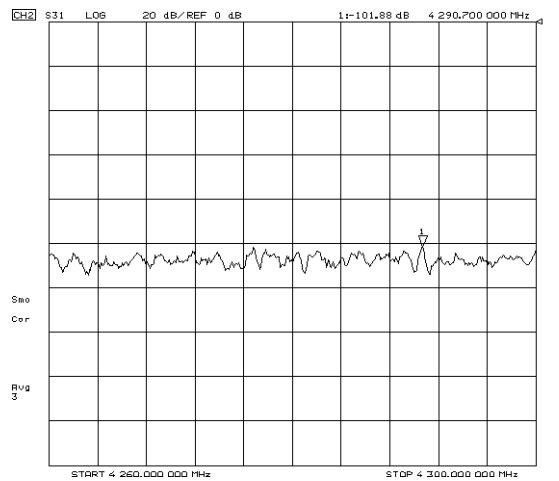
# Harmonic[2<sup>nd</sup>]

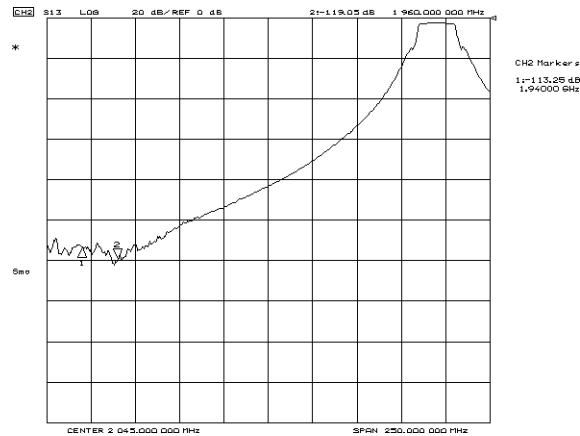
**# Isolation**

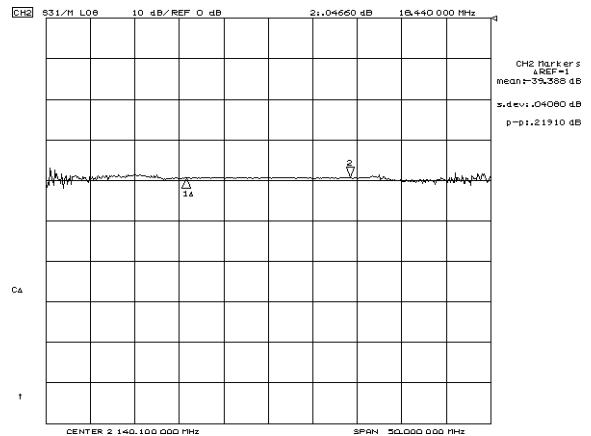
**# Output Coupling Value**

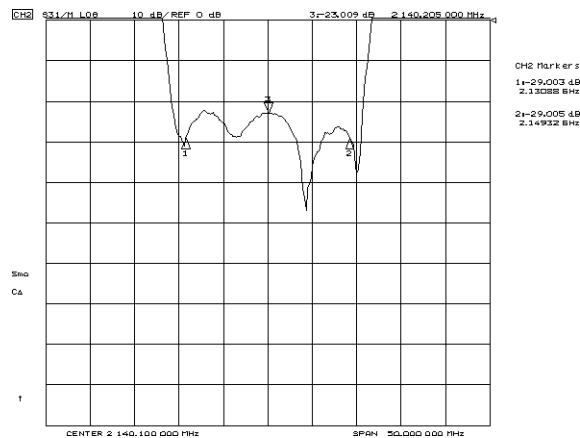
**# Directivity**

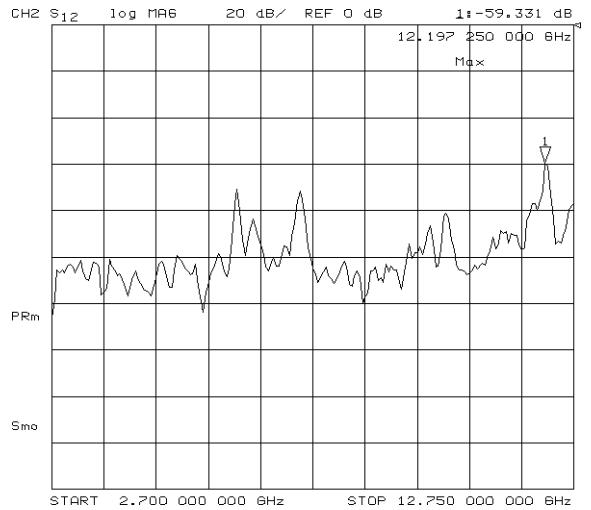
**# Attenuation[2.7~12.75GHz]**
