| | Customer | KJ Code | FT00320-6/1 |

## \* Test Data (Graph)

### 1. Up Link

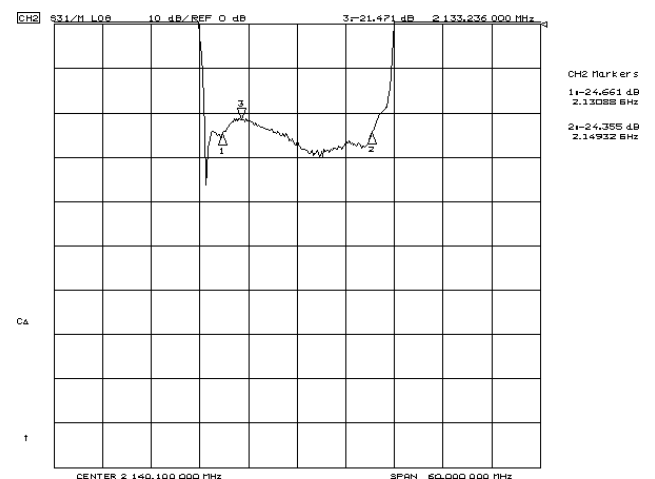
### # Coupling Port Directivity
